## AAA Components Test Lab, LLC.

## Parts and Material Analysis Report

Customer :		Manufacturer :	<b>Siemens</b>
Customer PO :	<b>186251A</b>	Part number :	<b>SO42P</b>
Date :	<b>January 30, 2015</b>	Date Code(s) :	<b>88+</b>
Report revision :	<b>0</b>	Quantity :	<b>total: 801 test: 40 (Random sample)</b>

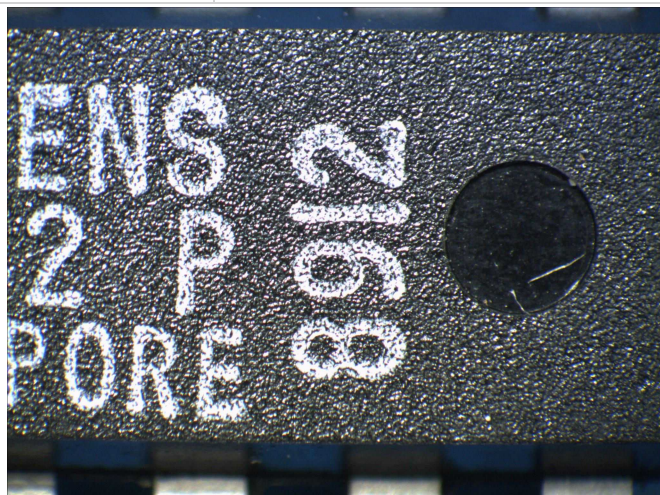
Device Top Surface after HCT

Observation	<p>After HCT (Heated Chemical Test) was performed, no secondary coating was removed.</p> <p>Device's package characteristic and dimensions matched manufacturer's specification.</p>
-------------	--

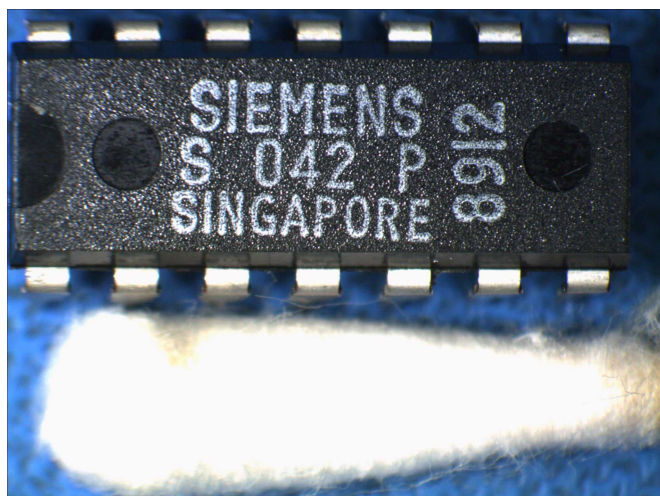
Cotton Swab Test Results after HCT

After HCT (Heated Chemical Test) was performed, no secondary coating was removed.

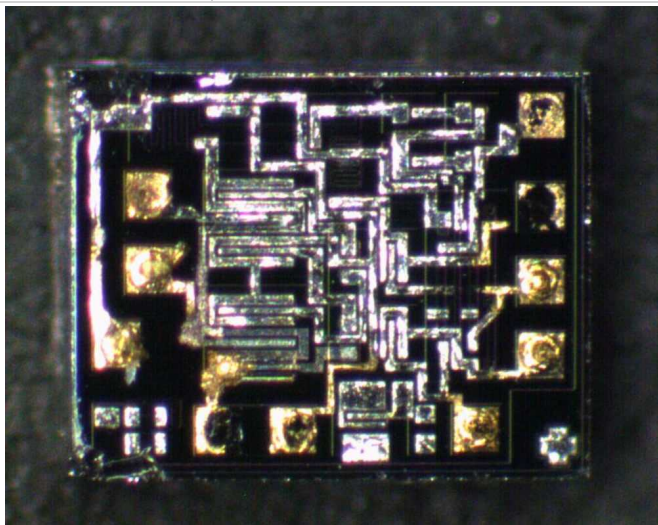
**Die Topography**

Observation	After Decapsulation was performed no markings were observed on the die.
-------------	---

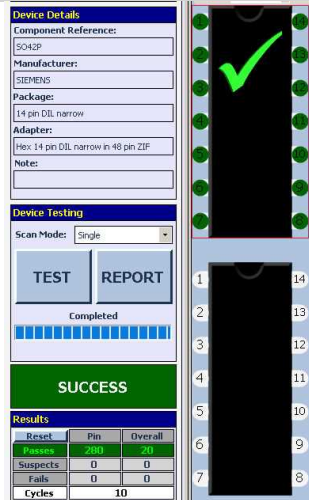
ABI Sentry Pin Correlation Test Results

All 40 devices passed all tested parameters.

Device pins correlated to the manufacturer's specification

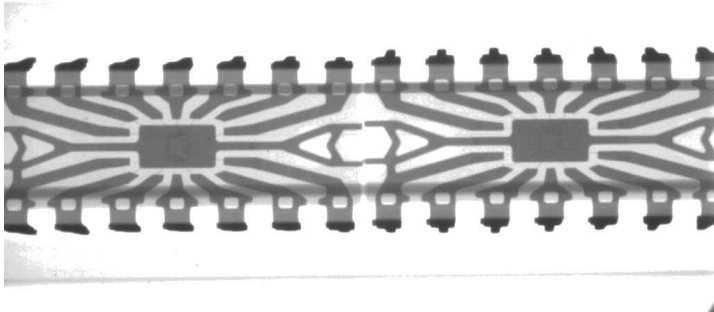
**X-Ray Analysis on Devices 1 and 2**

Observation	<b>X-Ray Analysis of (40) random sample(s) revealed the same internal structure on all the samples. No internal damages were observed during inspection.</b>  <b>Represented images are typical. All images are available on request.</b>
-------------	---
