## AAA Components Test Lab, LLC.

## Parts and Material Analysis Report

Customer :		Manufacturer :	<b>Siemens</b>
Customer PO :	<b>186251A</b>	Part number :	<b>SO42P</b>
Date :	<b>January 30, 2015</b>	Date Code(s) :	<b>88+</b>
Report revision :	<b>0</b>	Quantity :	<b>total: 801 test: 40 (Random sample)</b>

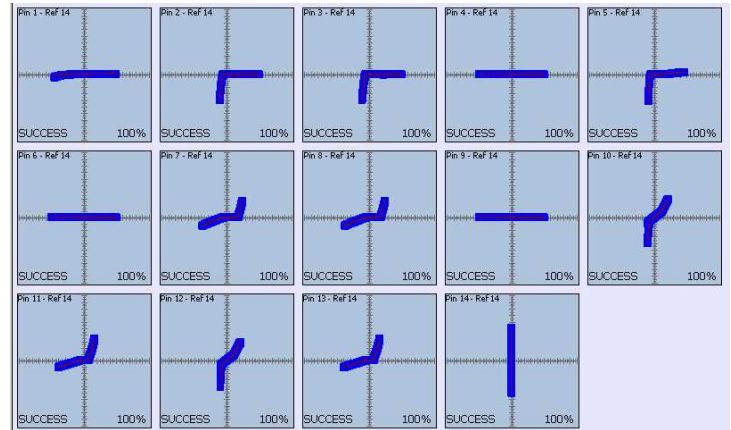
Curves: Typical Pin Structures

Total quantity tested **40 pcs.**Total quantity passed **40 pcs.**Total quantity failed **0 pcs. ( 0.00% )**
